Orphan Breakwaters - what protection is given when they collapse?

Orphan Breakwaters – what protection is given when they collapse?

Abstract

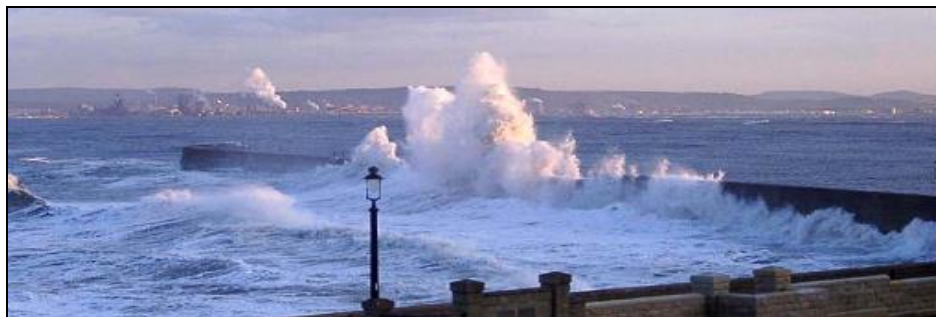
Figure 1: Wave attack on the Heugh breakwater at Hartlepool

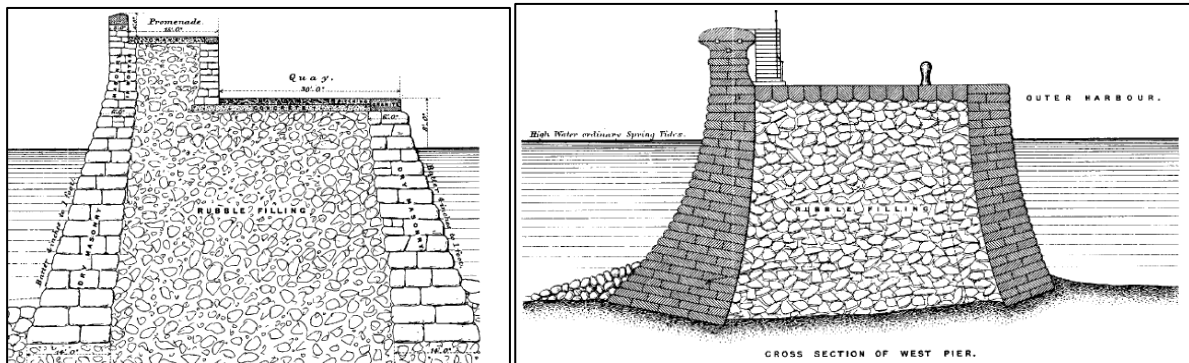
Figure 2: St Catherine's (left) and Whitehaven (right) breakwaters.

Example breakwater cross-sections from St Catherine's and Whitehaven are shown in Figure 2, Blyth and Alderney in Figure 3, Hartlepool and Peterhead in Figure 4.

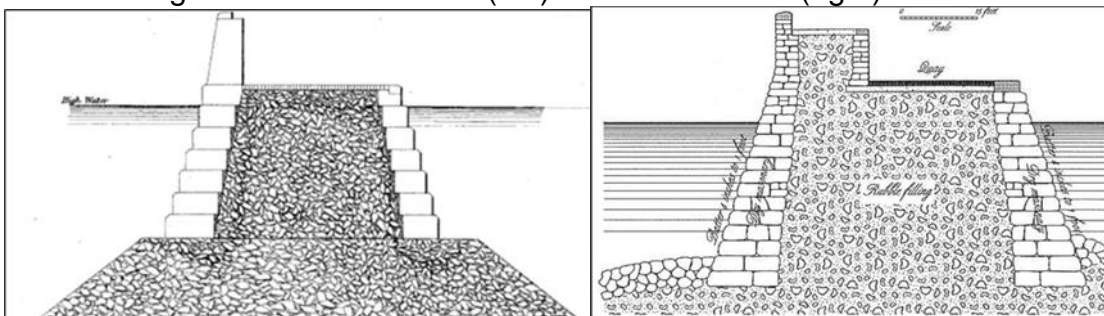
Figure 3: Blyth breakwater (left); Alderney breakwater (right)

correspond well with those at Peterhead (Figure 4) and moderately with those at Blyth (Figure 3). The smaller blocks in the other breakwaters reviewed were less well represented by these large block sizes.

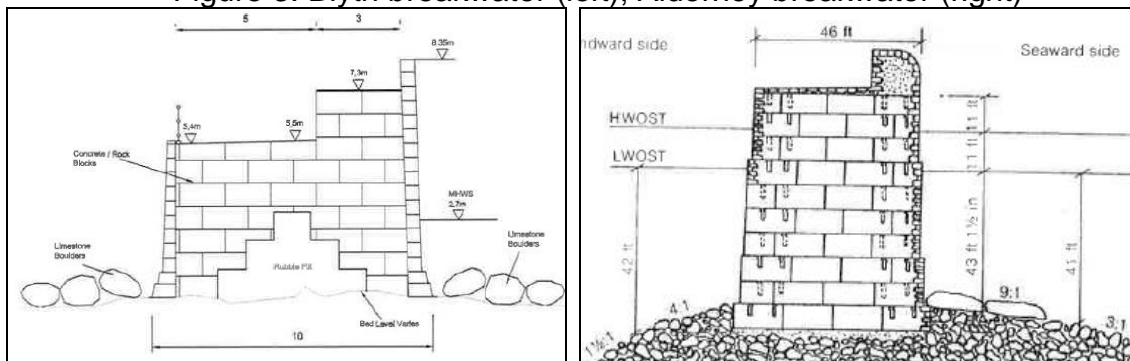
Figure 4: Hartlepool breakwater (left); Peterhead (right)

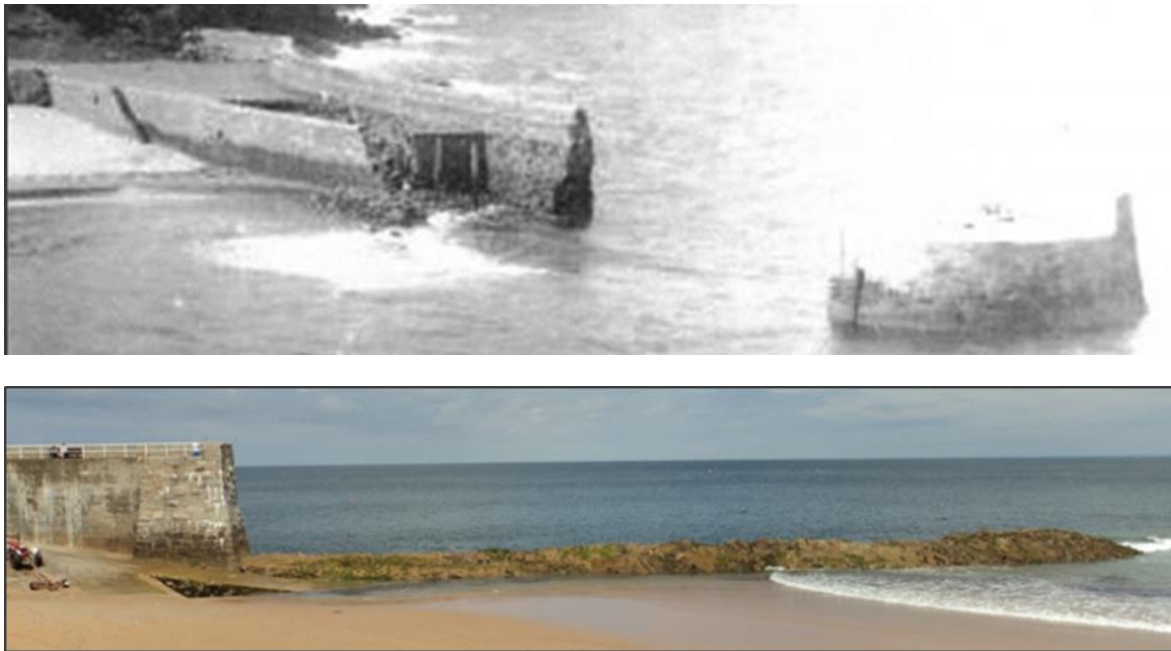
Figure 5: Greve du Lecq, Jersey: (top) after collapse in 1879; (bottom) in 2014

This paper starts by reviewing selected example breakwaters in Section 2, most of which have survived. (NB: It is particularly difficult to find details of failed structures as shown in Figure 5.) Section 3 describes the simplified analysis of block wall stability created to guide the design of the model tests. This section also presents results of the 'dry-build' tests to validate the spreadsheet model. The design of the main hydraulic tests are described in Section 4. The results of those tests are then separated, the collapse process is presented in Section 5, and the hydraulic results (reflections and wave transmission) in Section 6. Section 7 discusses the use of the wave transmission results in practice, and Section 8 offers a few remarks on further work.

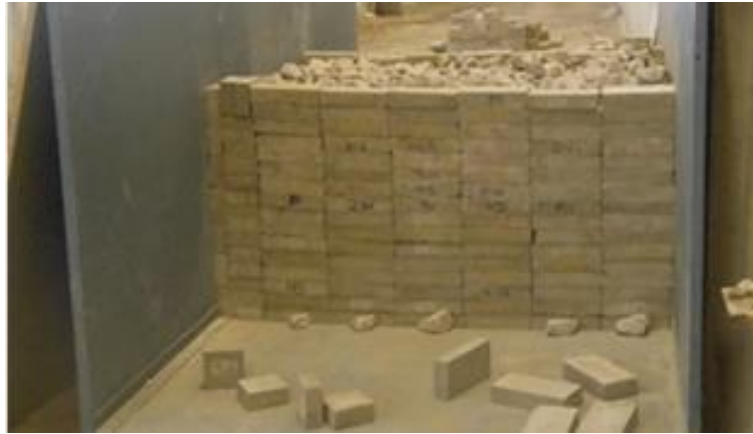
Figure 7: Dry-build timber frame with partially constructed dry-build test.

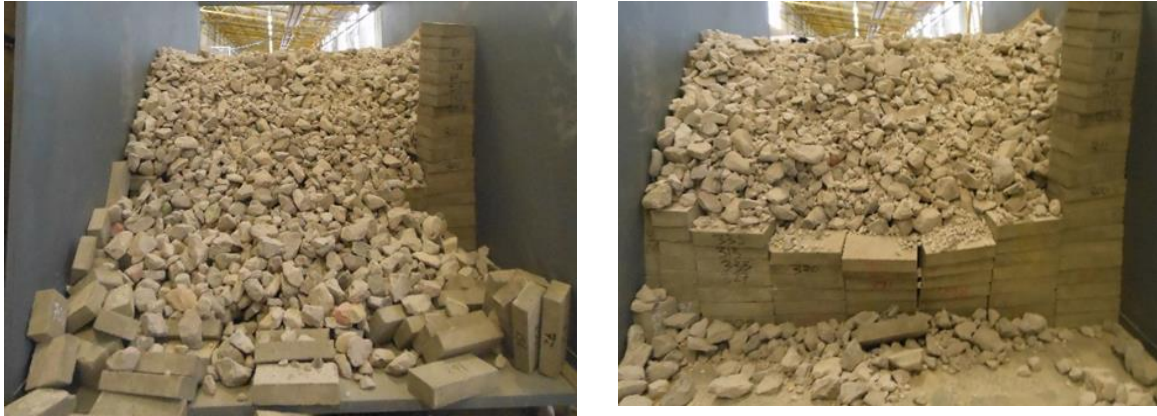
Figure 8: Failed dry-build. Left - immediately after collapse. Right - failed structure with spilled core removed to reveal arched (but still intact) wall toe.

The dry-builds were constructed one row at a time, slowly and carefully placing the fill as the walls got higher, until collapse. Initial dry-builds showed significantly higher stability than predicted by the analytical model; 20 rows high at failure in the dry-builds versus 11 or 12 in the model. This increased stability was attributed largely to jamming, or arching against the flume walls. As the blockwork wall grew higher, the centre of the wall started to bow, arching across the frame, pushing edge blocks outwards and against the side walls of the frame. The stiff timber frame provided lateral support, which pinched the blocks together and gave the wall greater strength against overturning. Arching of a wall in plan by up to 50mm (1.5m prototype) at the centre of the crest was observed. Once this was exceeded, the arch would snap through suddenly, the wall would unzip along the vertical centre line, and the structure would collapse entirely. A typical failed dry-build is shown in the left-frame of Figure 8, accompanied on the right by the same failed structure with the spilled core material dug out. This reveals the arched, but still intact, toe of the wall, about which the upper section toppled. It shows that the wall overturned with its hinge located not at the bottom row, but a few rows up.

This contrasts the spreadsheet model which always showed rotation about the lowest row. The difference of behaviour in the dry-builds may be, in part, due to the arching effect providing additional strength to the wall before a brittle collapse, but also perhaps due to the stability model's assumption of simple Mohr-Coulomb lateral earth pressure. This theory assumes that the force applied by the fill is horizontal, whereas strictly it acts slightly downwards and diagonally, activating friction between the fill and the wall.

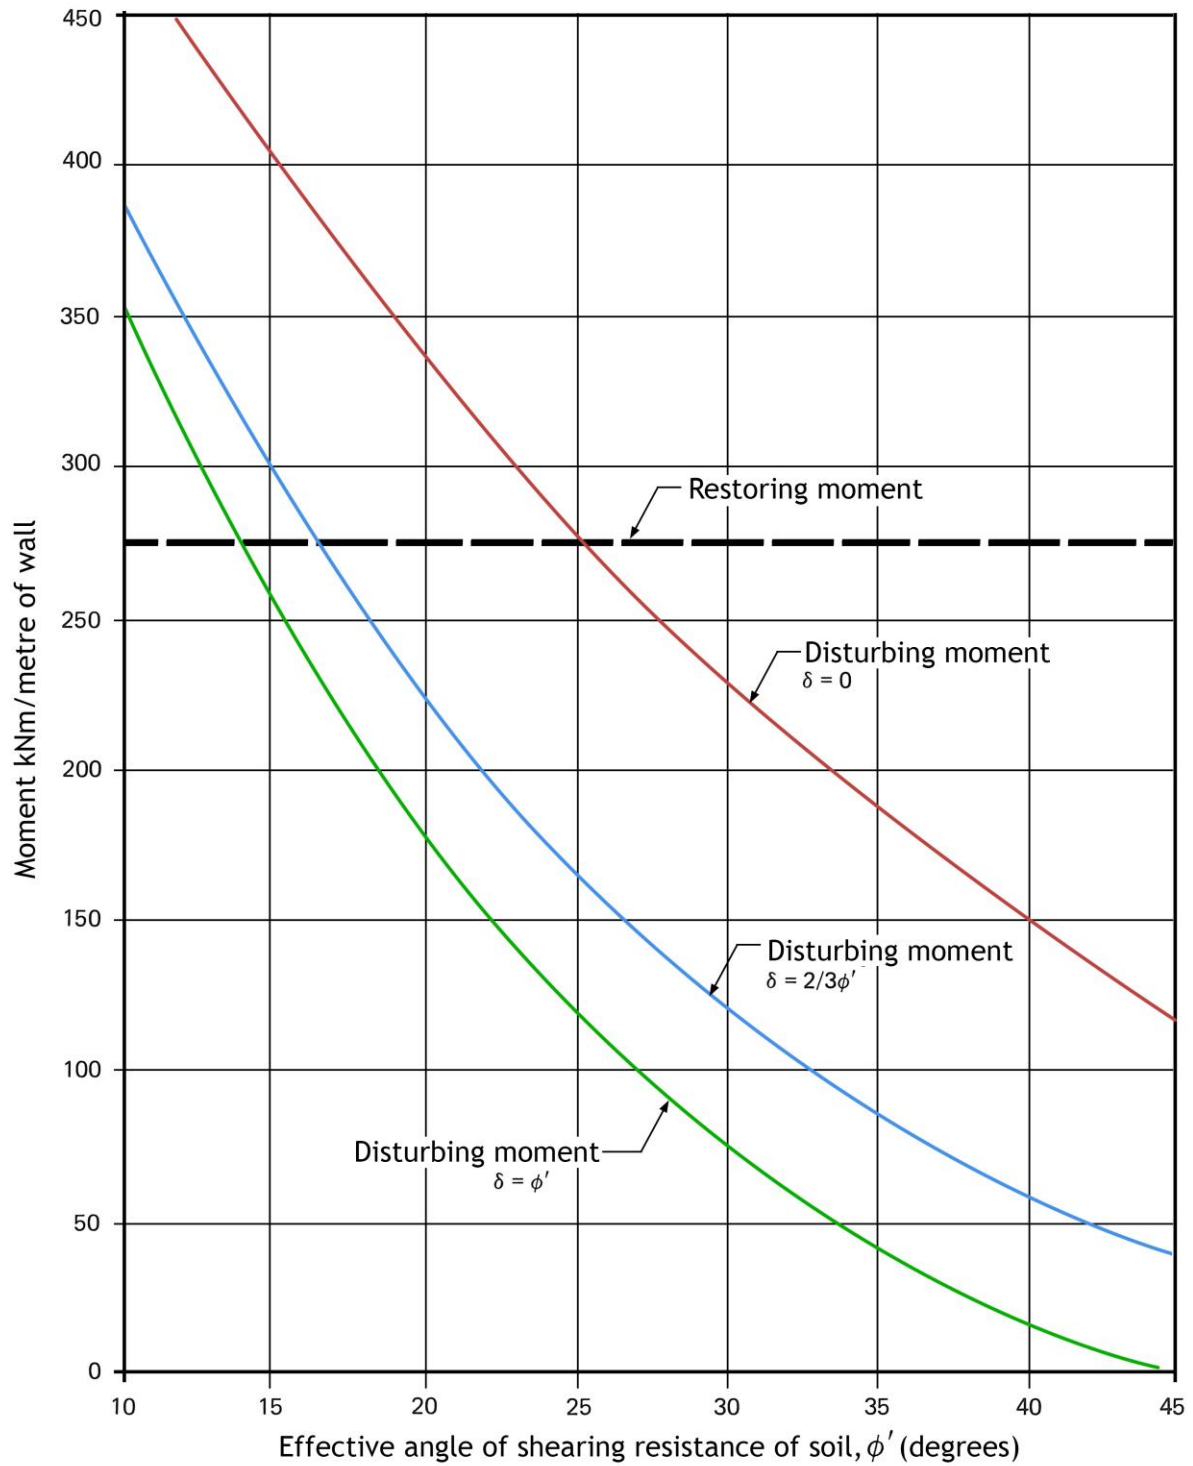
Figure 9: Effect of internal friction angle on overturning (disturbing) moment. Adapted by Adrian Pearson from Bray & Tatham (1992).

The downward frictional component of this pressure tends to stabilise the wall by clamping the lower blocks more tightly into place, reducing the overturning, or disturbing, moment. This effect was noted by Bray & Tatham (1992) and is illustrated in Figure 9 from their book. It is noted that for an internal friction angle of $\phi=25^\circ$ and no wall friction angle ($\delta=0$), the disturbing moment is equal to the restoring moment. When wall friction is increased to $\delta=\phi$, the restoring moment becomes 2.3 times the disturbing moment. It is uncertain whether the full effect of wall friction is activated on the scale of the dry-builds, but its omission in the analytical model along with the arching effect may explain partially why the simple model under-predicts wall stability and does not show toppling over a toe section.

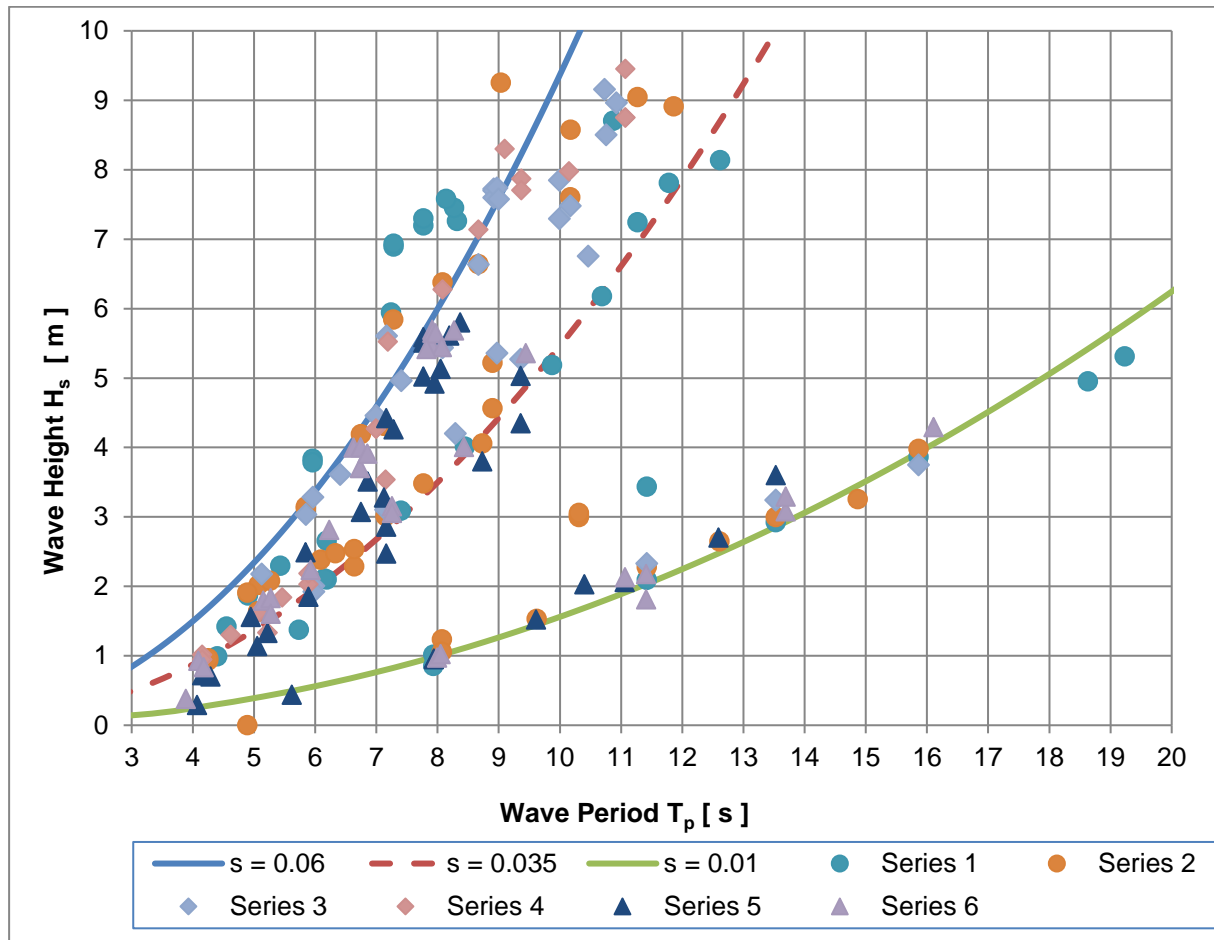
Figure 10: Test conditions, Storm ($s=0.06$), Persistent ($s=0.035$) and Swell ($s=0.01$)

Wave conditions at the chosen 1:30 scale are illustrated in Figure 10, extending up to $H_s \sim 9.0\text{m}$ (at 1:30 scale), typical of large North Sea storms. Three wave regimes were used, identified by their target wave steepness: Storm ($s \sim 0.06$), Persistent ($s \sim 0.035$) and Swell ($s \sim 0.01$).

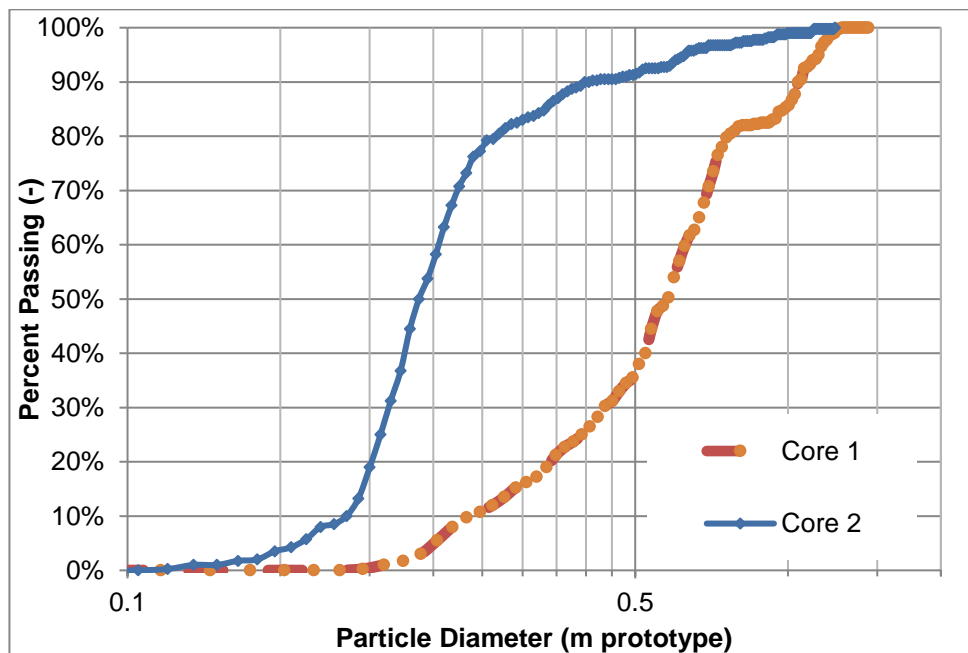
Figure 11: Rubble core samples, original (core 1) and finer (core 2).

The model core material was widely graded with $D_{\max} \sim 1.5\text{m}$ (Figure 11), to ensure that the maximum rock size was smaller than a typical wall block. Recalling that a typical core will be formed by discarded wall stones, chippings, and natural tout-venant ('all-in') rubble core, the natural upper-limit is indeed the wall-block size, smaller than Peterhead and Blyth wall blocks. For the final Test series 6, a finer core (core 2) was used to explore its effects on the collapse process.

The test section in Series 6 was very similar to that in Series 5, again with main walls of 11 rows, a protected crest using large slabs, and a parapet wall of two layers of blocks placed end-on, except for the replacement of fill by the finer Core 2, see Figure 11.

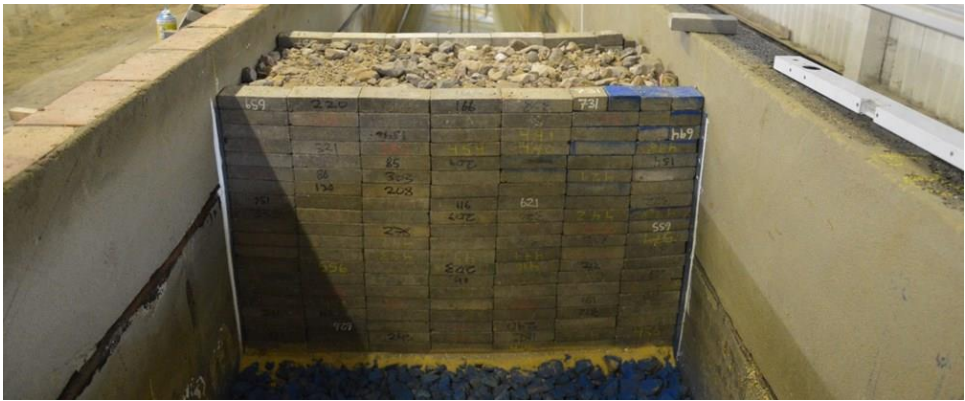
Figure 12: Example test structure in flume.

Tests in the flume were organised by structure and number. One complete set of tests on a particular structure is called a “Series”. Each Series comprised different test parts, progressing from Test Part 1 – the first waves – through to the final test where the collapsed breakwater reached a stable form. A summary is shown in Table 2 and a full description of series and test parts is given by Allsop et al (2017). An example test structure in the flume is shown in Figure 12.

In the wave flume, all blockwork walls were constructed on a rubble mound from flume floor at -24m to a platform level nominally at -10m, see example in Figure 12. All levels are expressed relative to nominal still water level of 0.0m.

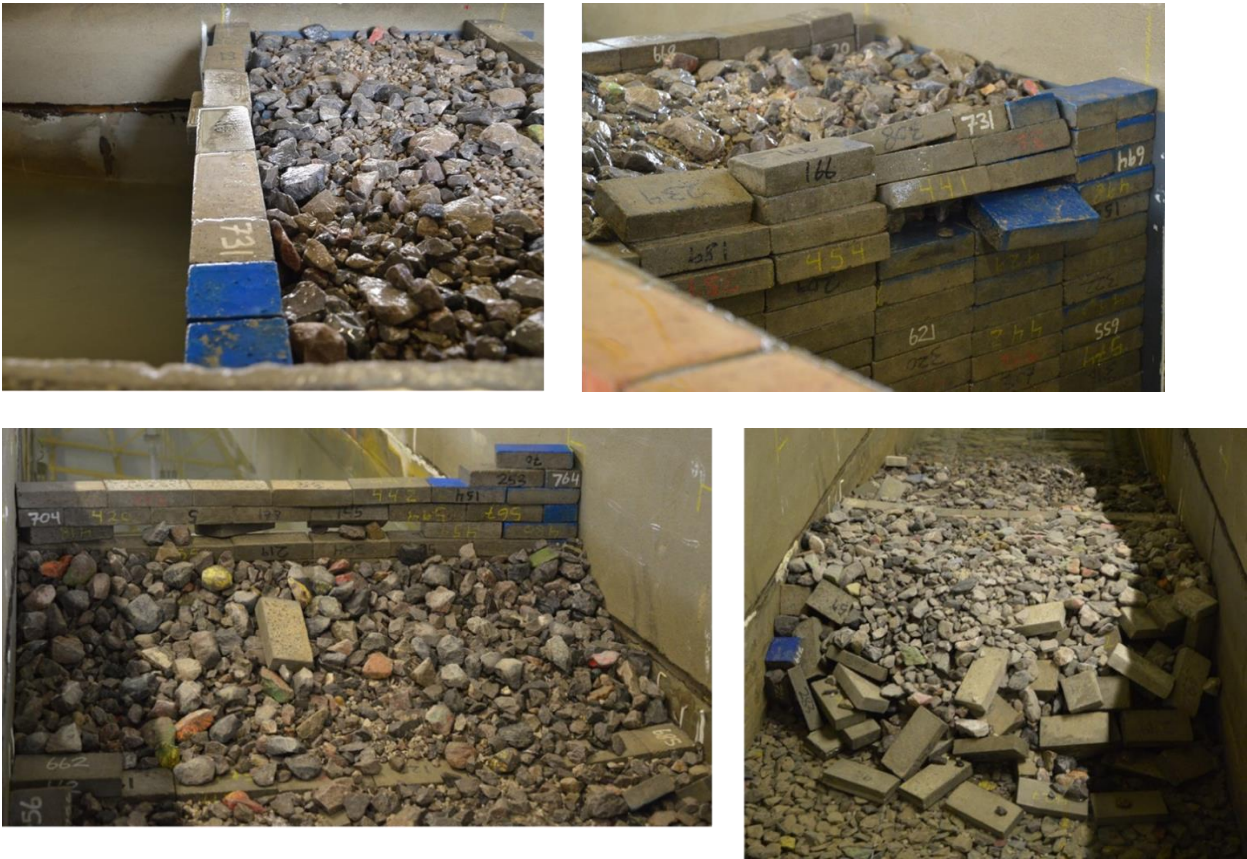
Figure 13: Progressive failure of Series 1.

Multiple blocks were extracted seawards from the front face as overtopping and local wave pressures opened multiple gaps in the blockwork at a high level. Some courses resisted further due to arching of the blocks against the sides of the flume, clearly a model effect. As more blocks were extracted, more overtopping penetrated into the rubble fill, forcing out further blocks. Once the front wall had failed at about $H_s=7.2\text{m}$, wave backwash steadily washed fill out until the seaward blocks and rubble fill were graded to a relatively shallow slope angle down the front of the structure. With the front wall down, waves broke onto the new rubble beach, attacking the rear wall significantly less. The rear wall itself again showed considerable arching, probably leading to the wall staying intact to $H_s=8.7\text{m}$, much longer than might be expected without lateral restraint. Photographs of this progressive type failure are shown in Figure 13. Measurements of front and rear wall crest heights are shown in Figure 14. It is noted that crest level is defined as the highest point of the structure. After the rear wall failed, the core may often have been higher than the remaining wall sections.

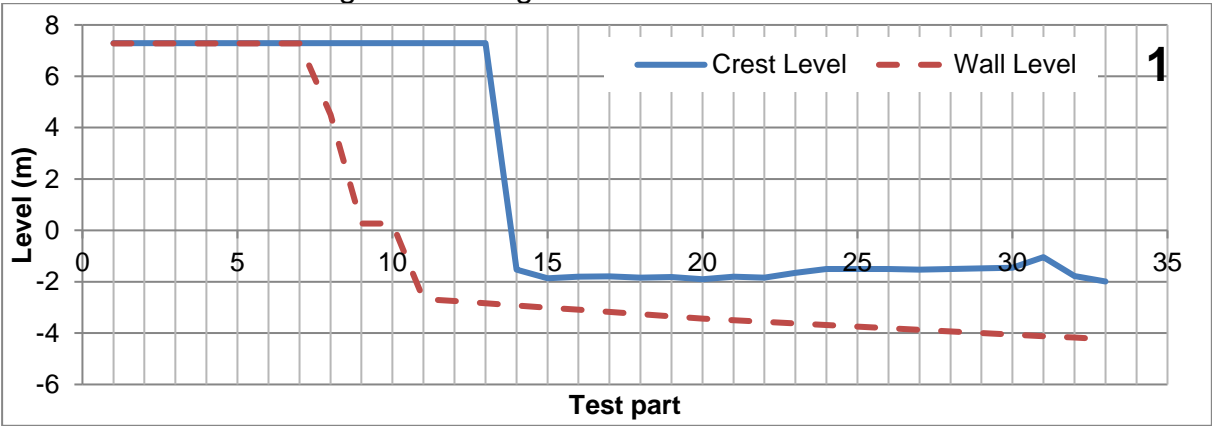
Figure 14: Progression of Test Series 1, test parts 1-33

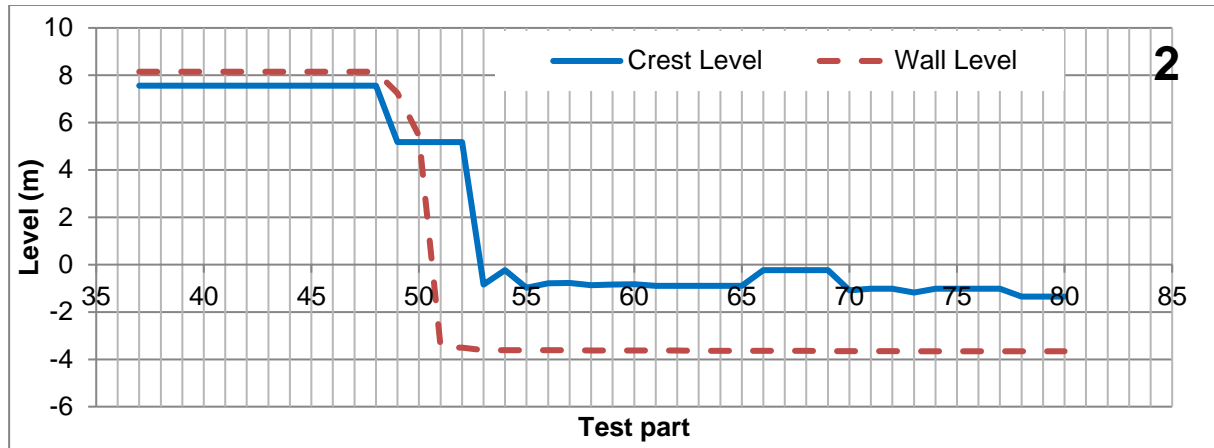
Figure 15: Progression of Test Series 2, test parts 37-80.

The wall in Series 2 was constructed 18 blocks high on the front, but fill and back wall were taken only to 16 courses. Blocks were again laid in bond. The geotextile in Series 1 was omitted as it was not useful. Sixteen test parts (each 500 waves) were required, failure occurring over test parts 48-52 ($H_s=8.6-8.9\text{m}$), illustrated in Figure 15.

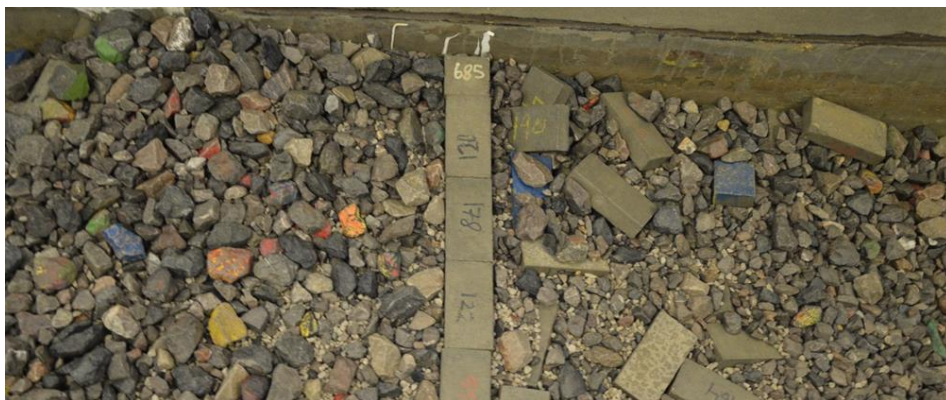
Figure 16: Post collapse view of Series 2, seaward side to right. Note the intact remnant of the wall toe.

Again the speed of wall collapse was probably delayed by arching effects giving artificial restraint. As seen before, the front wall mostly collapsed seaward. The remaining courses of toe blocks acted to reduce erosion of fill material, a process that has been seen on site for collapsed walls. Measurements of rear wall and crest heights are shown in Figure 15. The eroded profiles (see Figure 16) were very similar to those seen for Series 1.

One unexpected result of the dry-build tests was that the hinge of rotation was some 3-4 rows above the toe of the wall, see especially Figure 16. An explanation has been derived from the effect of friction between the fill and wall in Chapter 3. Supporting evidence is also given by the collapsed breakwater at Skateraw (near North Berwick) shown in Figure 23. This breakwater had been constructed 1799 -1825 by two farmers, Brodie of Thorntonloch and Lee of Skateraw, to import coal, and export limestone and potatoes, see Graham (1969). The 85m long breakwater / pier was probably destroyed 1853 -1892.

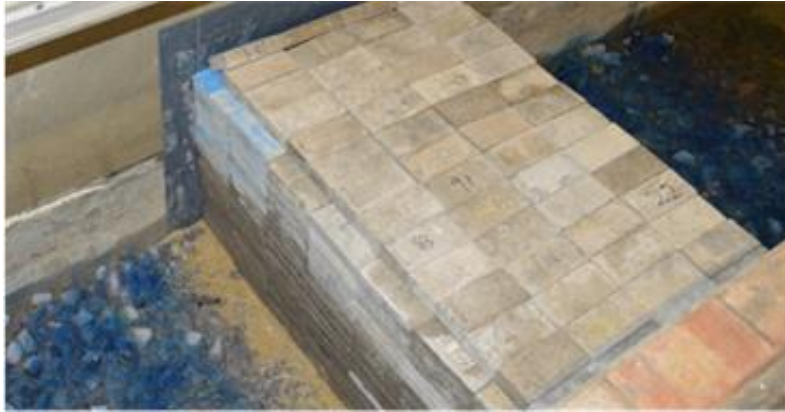
Figure 17: Series 3 with protected crest.

The wall in Series 3 was built 15 blocks high in columnar bond with standard fill. As this was rather lower than Series 2, it was expected that overtopping damage might be greater. A blockwork 'capping' layer on fines brought the section height to 16 blocks all the way across, see Figure 17.

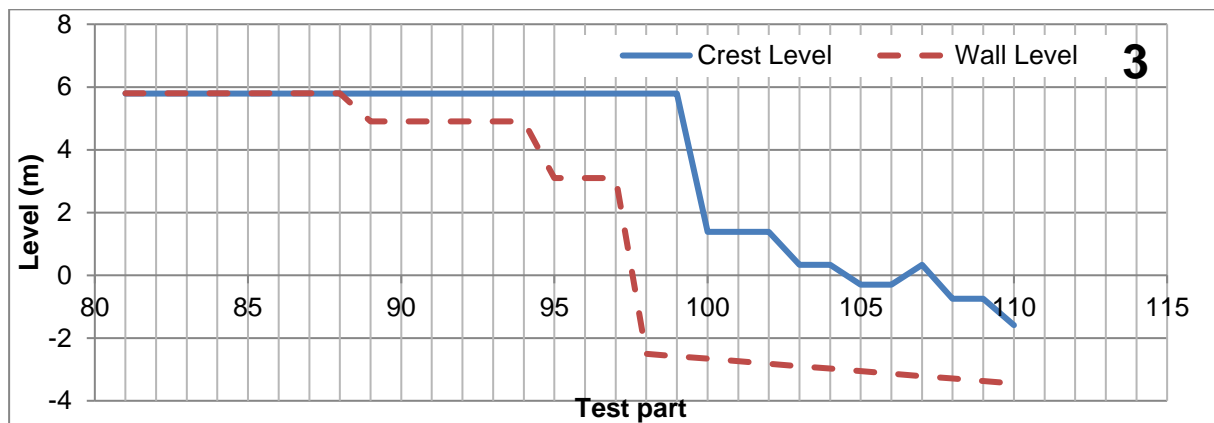
Figure 18: Progression of Test Series 3, test parts 82-110

With the lower initial crest level, the wall in Series 3 did indeed suffer increased overtopping. At $H_s=7.05\text{m}$, the front edge of the capping layer began to lift due to the up-rushing waves. This caused the crest protection to deform, continuing until the row had been either thrown backwards onto the structure or washed forwards creating a gap in the front of the wall. Once this gap had been opened, waves were able to penetrate under the cap, washing individual blocks off relatively quickly. This allowed waves to pull the fill and front wall down within 500 waves, forming a profile similar to those seen in Series 1 and 2. Measurements of rear wall and crest heights are shown in Figure 18.

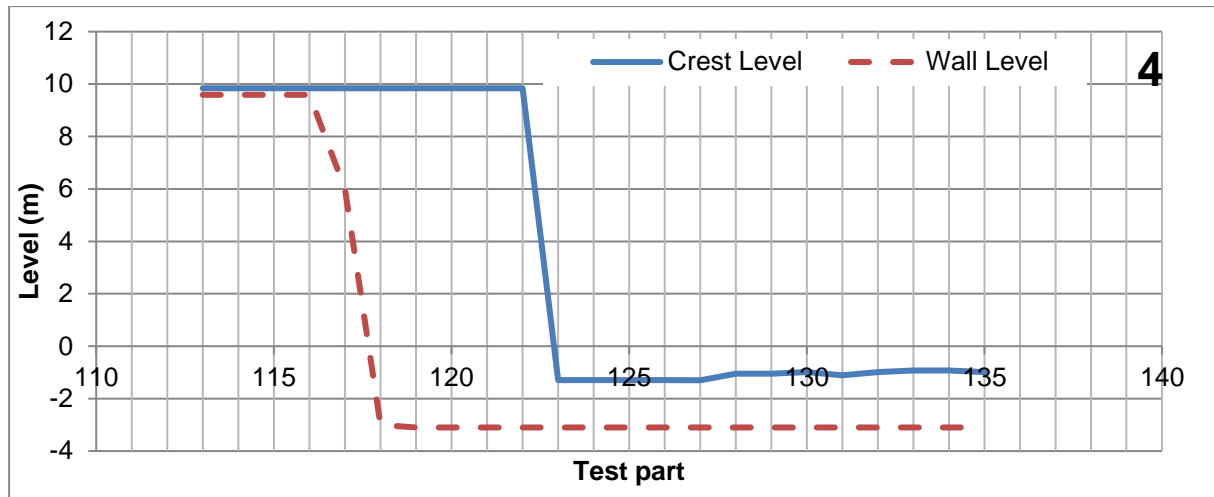
Figure 19: Progression of Test Series 4, test parts 113-135

The following tests ($H_s=8\text{m}$) steadily brought the front wall down course by course, washing the fill out with it. The rear wall failed in a more brittle mode, perhaps due to reduced arching in this build. More core was washed over into the rear face when it collapsed, and the rear wall collapsed more as a single unit in Series 4 than in Series 3. Measurements of rear wall and crest heights are shown in Figure 19.

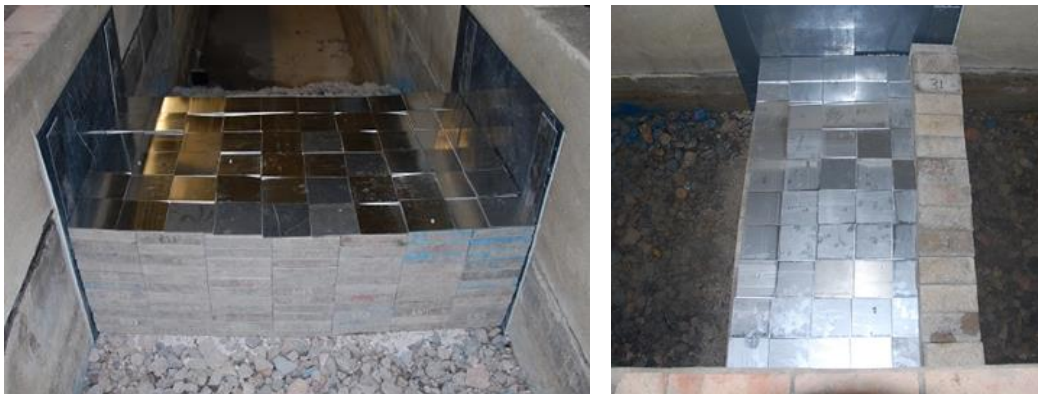
Figure 20: Test section for Series 5, showing crest slabs and parapet wall

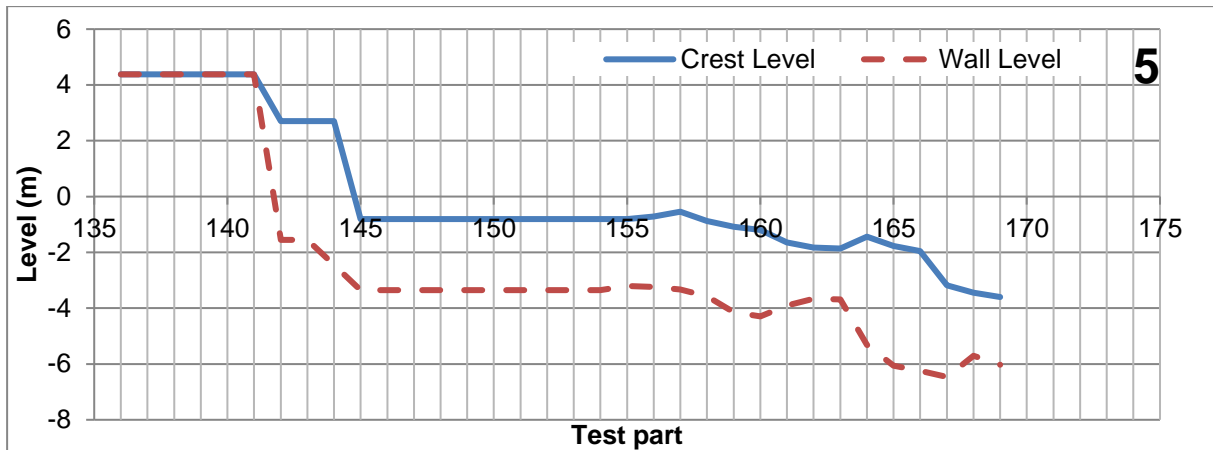
Figure 21: Progression of Test Series 5, test parts 136- 169

Alongside the reduced crest level, a further change for Series 5 was to reduce the test water level by 1.5m to a nominal level of -1.5m. As before, wave conditions were ramped up at the 'storm' steepness ($s \approx 0.06$). In Test 138 at $H_s = 4.3\text{m}$, some parapet wall blocks started to slide backwards. During Test 139 at $H_s = 4.9\text{m}$ more crest blocks were pushed backwards, thus allowing wave forces to lift the parapet wall blocks. During Test 141 ($H_s = 5.8\text{m}$) half of the front wall collapsed around the hole left by two blocks extracted previously. During Test 142 (at essentially the same wave condition) the remaining half of the front wall collapsed. Most capping slabs were swept over the crest onto the rear foundation. The rear wall collapsed during Tests 143 – 145 ($H_s \sim 5.5\text{m}$). Measurements of rear wall and crest heights are shown in Figure 21.

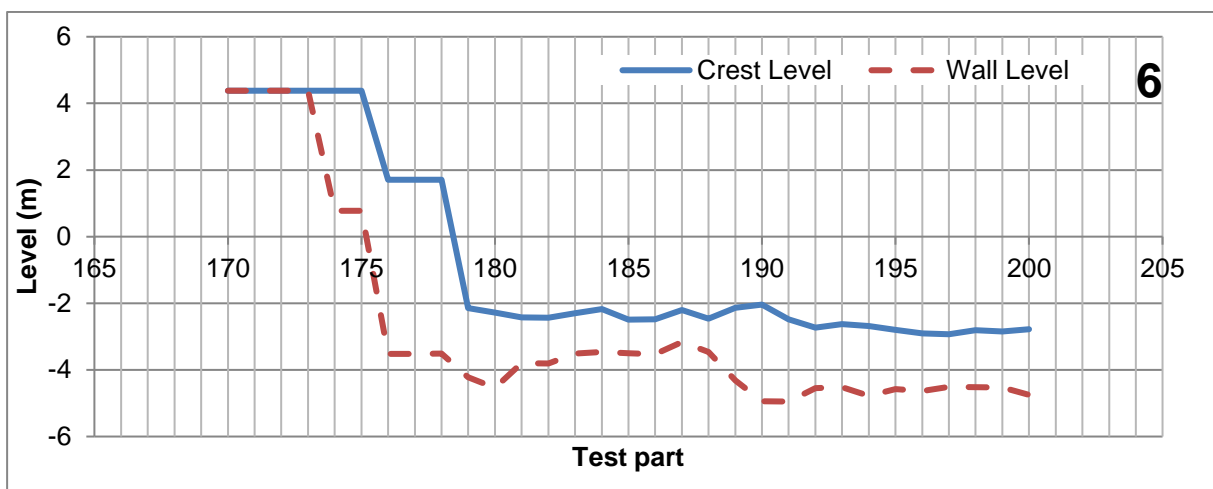
Figure 22: Progression of Test Series 6, test parts 170-200

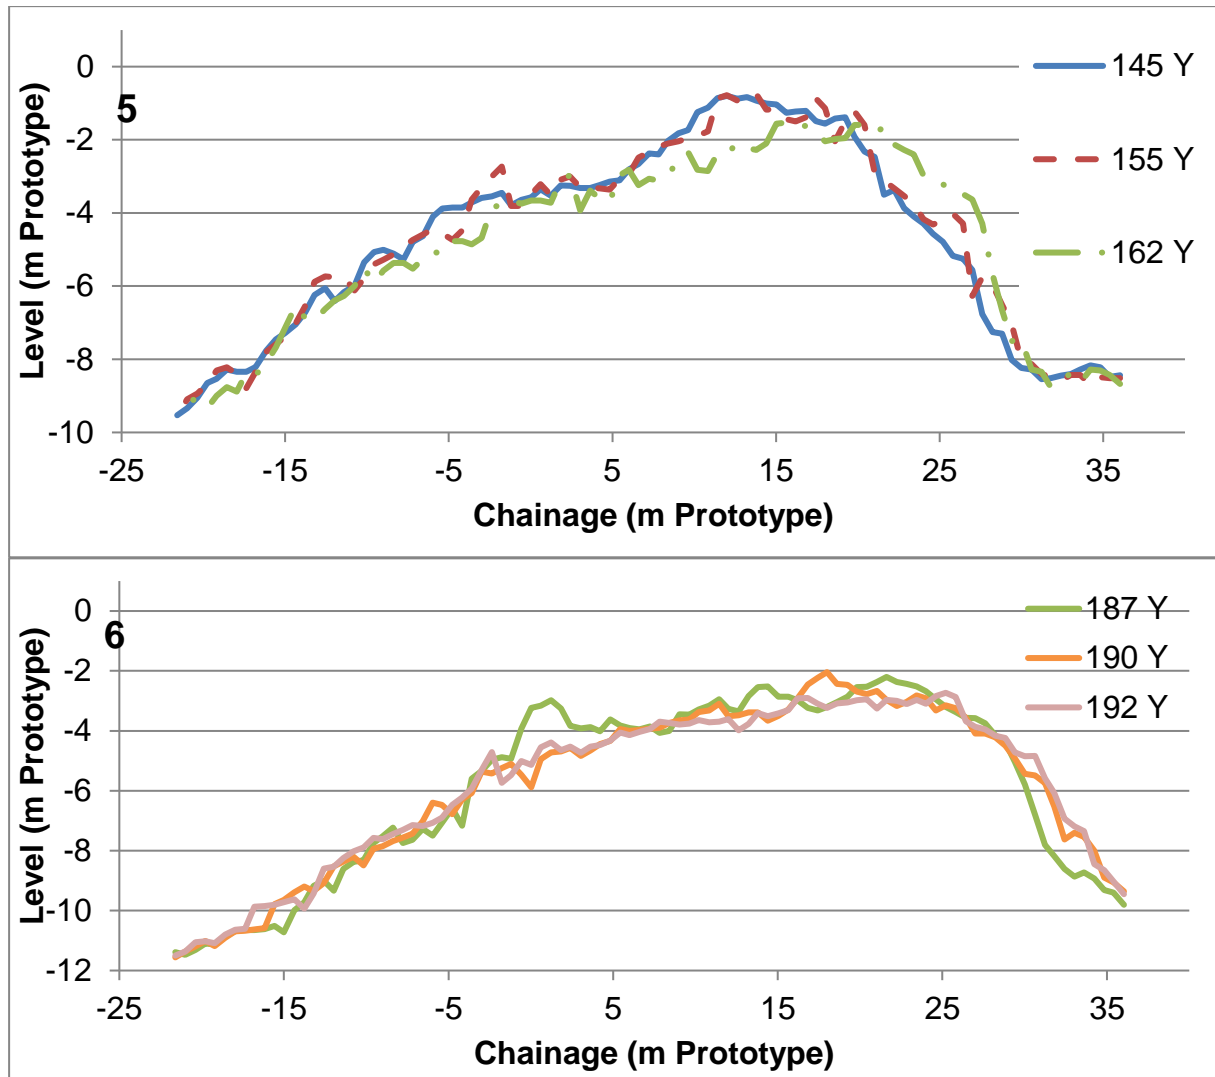
Figure 23: Typical evolution of collapsed profiles, Test Series 5 and 6.

Waves in Series 6 were increased from $H_s=2\text{m}$ to $H_s=5.7\text{m}$ when the first block was extracted from the front face, and crest protection slabs began to be washed off. Further tests at $H_s=5.7\text{m}$ steadily extracted more blocks, particularly in rows just below the capping layer. During Test 173 a row of blocks was extracted and the parapet wall was pushed back so that it rested mainly on the crest slabs, rather than on the main front wall blocks. Further waves pulled blocks out seaward, causing a large hole in the centre of the section. This collapsed quite quickly, and the front wall was pulled over during Test 177 ($H_s=5.5\text{m}$). The rear wall failed faster than in previous tests, probably due to reduced arching. The top blocks were pushed back, then core material filled around them to form a fairly stable slope; see Figure 22. Figure 23 below shows the typical evolution of collapsed profiles.

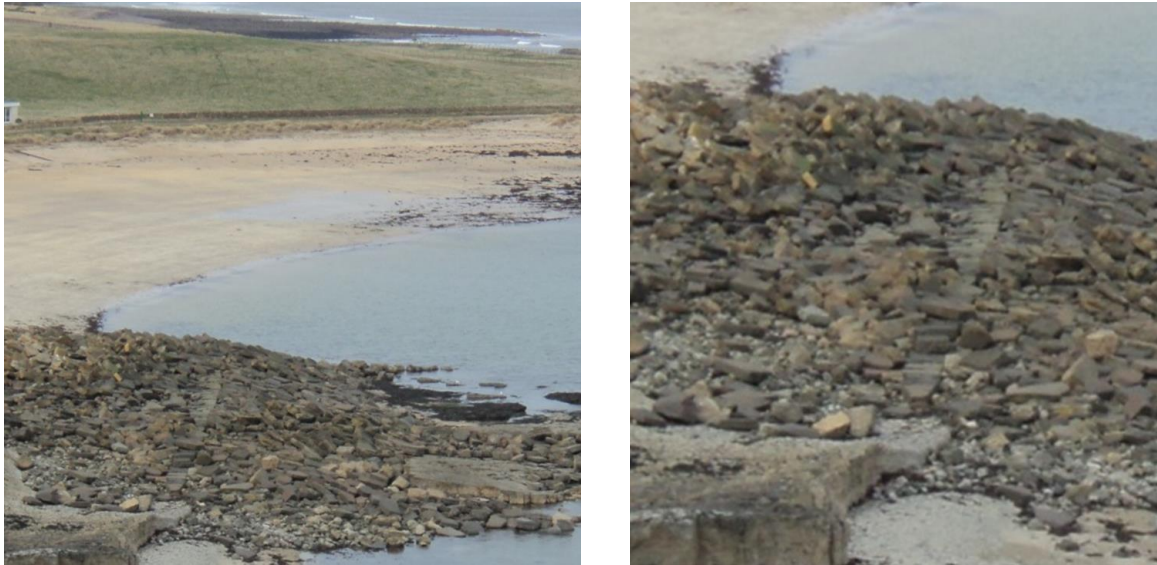
Figure 23: Remains of breakwater at Skateraw, probably collapsed between 1853 – 1893, still showing remains of wall foundation

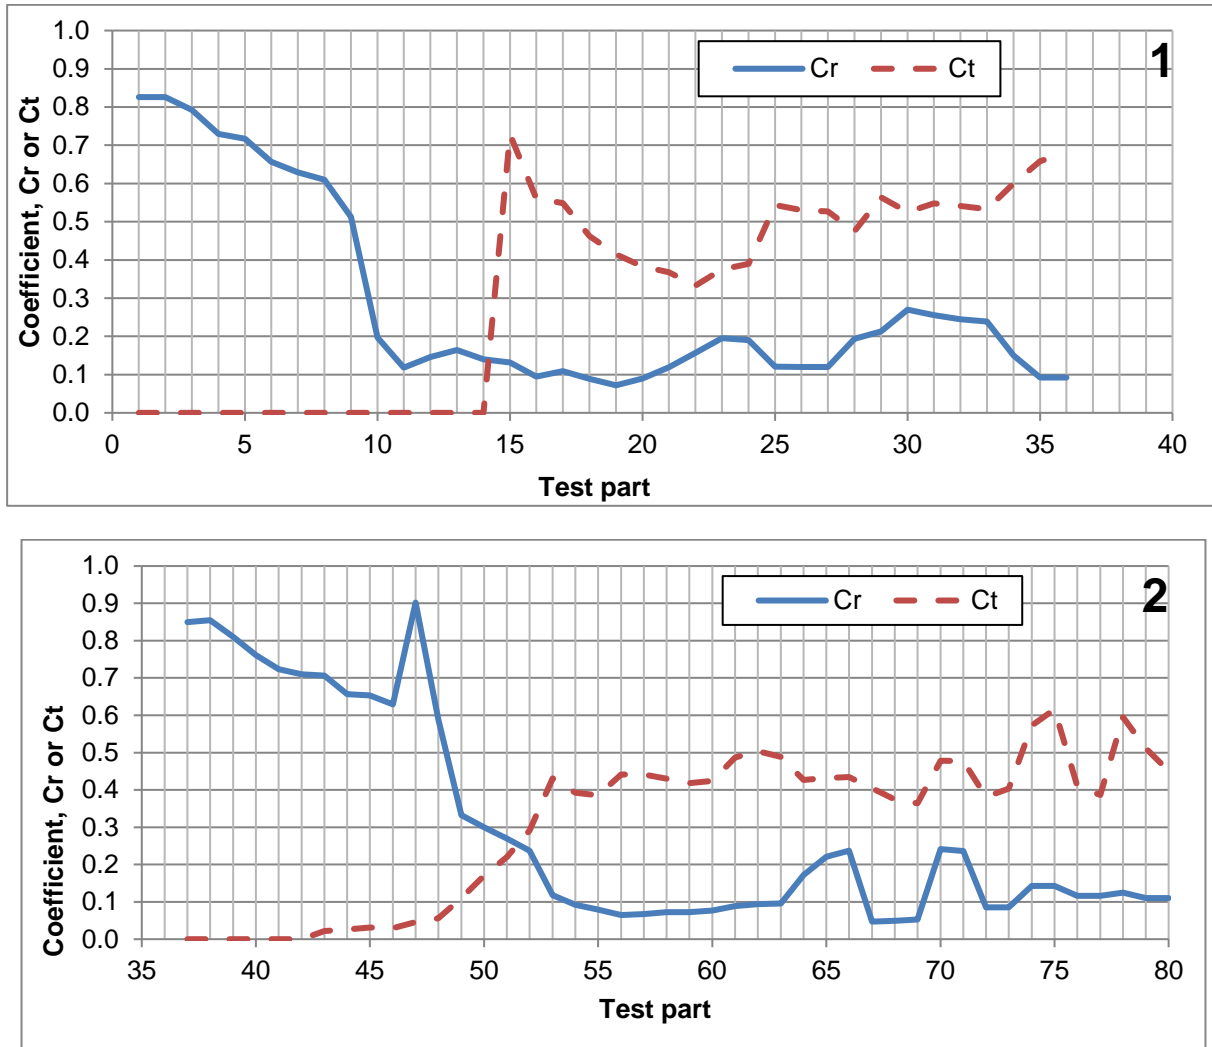
Figure 24: Reflections and transmission, Series 1 (top) and Series 2 (bottom).

For Series 1, the reductions in C_r in Figure 24 suggest that damage to the front wall started relatively early. Conversely, wave transmission shown by C_t depends strongly on failure of the rear wall. The sudden increase of transmission in Test Part 14, therefore, correlates well with observations of the rear wall failure. Thereafter, reflections continue at a relatively low level, $C_r < 0.25$, whilst transmission stabilised at $C_t \sim 0.55$.

In Series 2 (also Figure 24) the process of wall failure was more abrupt with increased transmissions around Test Part 52 following soon after the fall in reflections as the rubble slope develops from the debris of the front wall collapse in Test Part 49.

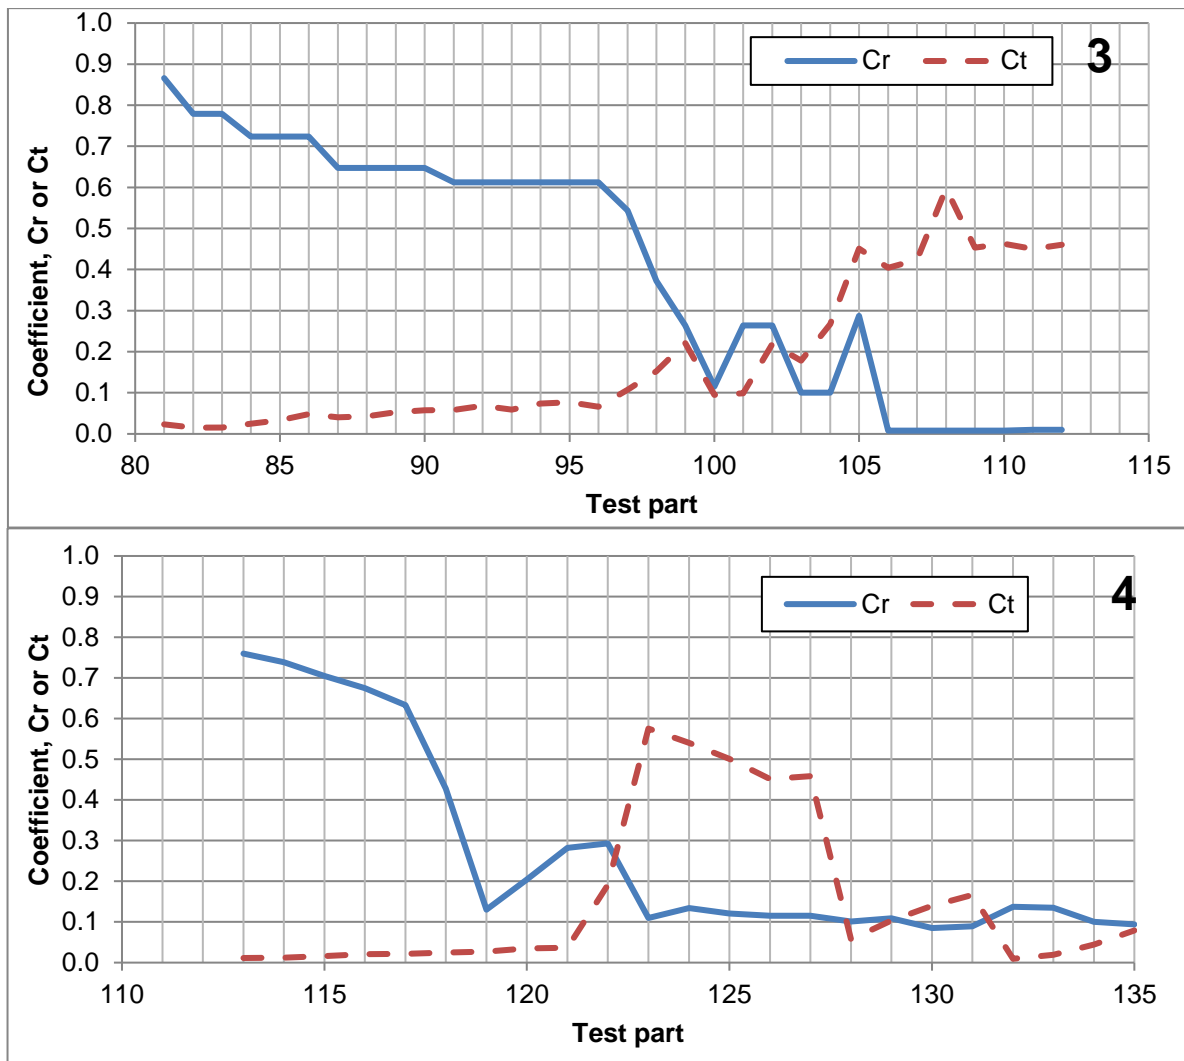
Figure 25: Reflections and transmission, Series 3 (top) and Series 4 (bottom).

The wall failure in Series 3 was more gradual with reflections reducing as waves overtopped more (Figure 25). The rear wall failed incrementally, with transmission increasing as reflections reduced. This process was repeated in Series 4 (also in Figure 25), again with a lag in lower reflections as the front wall fails before the rear wall.

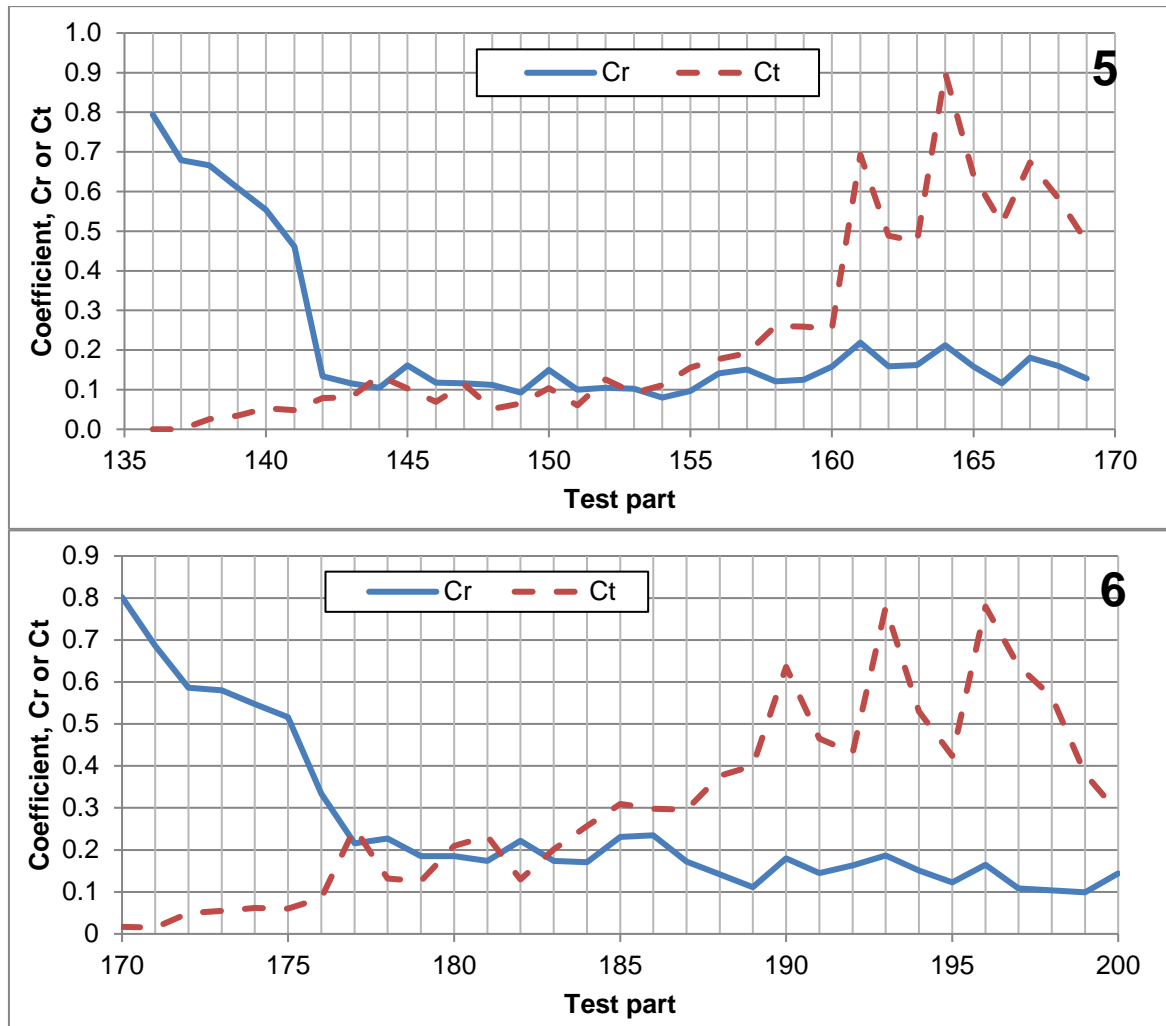
Figure 26: Reflections and transmission, Series 5 (top) and Series 6 (bottom).

As expected, Series 5 and 6 behaved similarly. Reflections (Figure 26) fell rapidly with increased overtopping, then as the vertical front face degraded to a slope. Again the increase of transmission (also Figure 26) was delayed until the rear wall collapsed, then varying with the test wave condition.
